**A CEQA Review and Evaluation  
For Historical and Architectural Significance of  
the former Capt. Charles and Dr. Margaret Kimball House,  
544 Tucker Street, Healdsburg, Sonoma County, CA 95448  
APN 002-281-023, a 73.12' x 320' lot  
in Township 9 North, Range 9 West, MDM,  
Within the former Sotoyome Rancho**

\*Resource Name or #: Capt. Charles and Dr. Margaret Kimball House

Intensive. Historic Resource Evaluation, as required by Healdsburg Municipal Land Use Code 20.24.205 Historic Demolition Permit Application

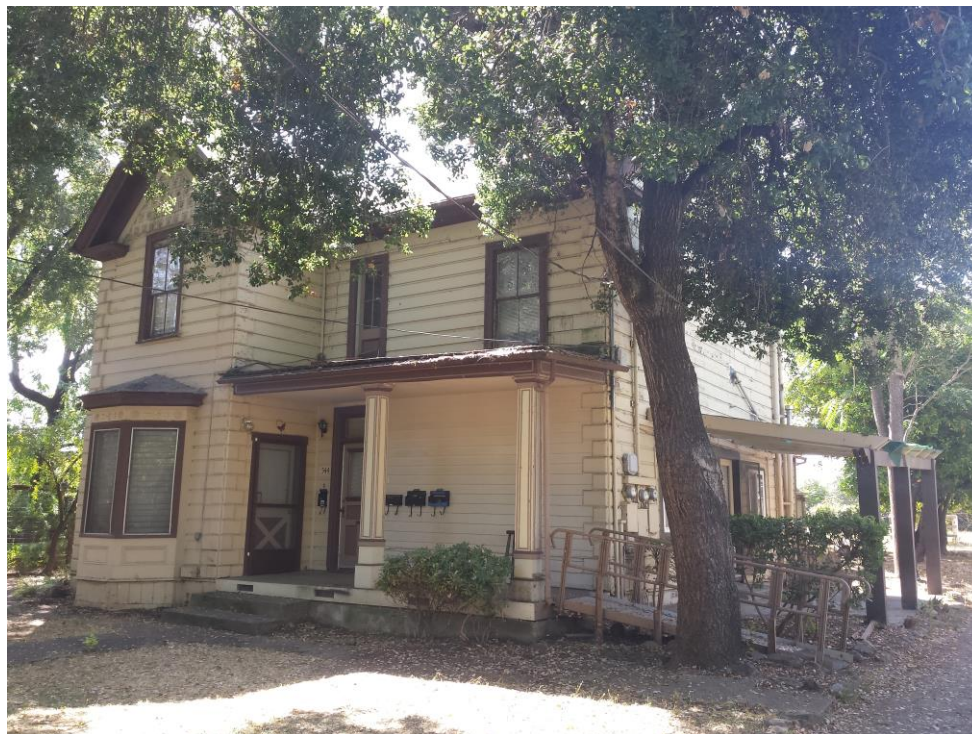
**P5b. Description of Photo:**

N and W elevations, photo view  
toward SE, 12/17

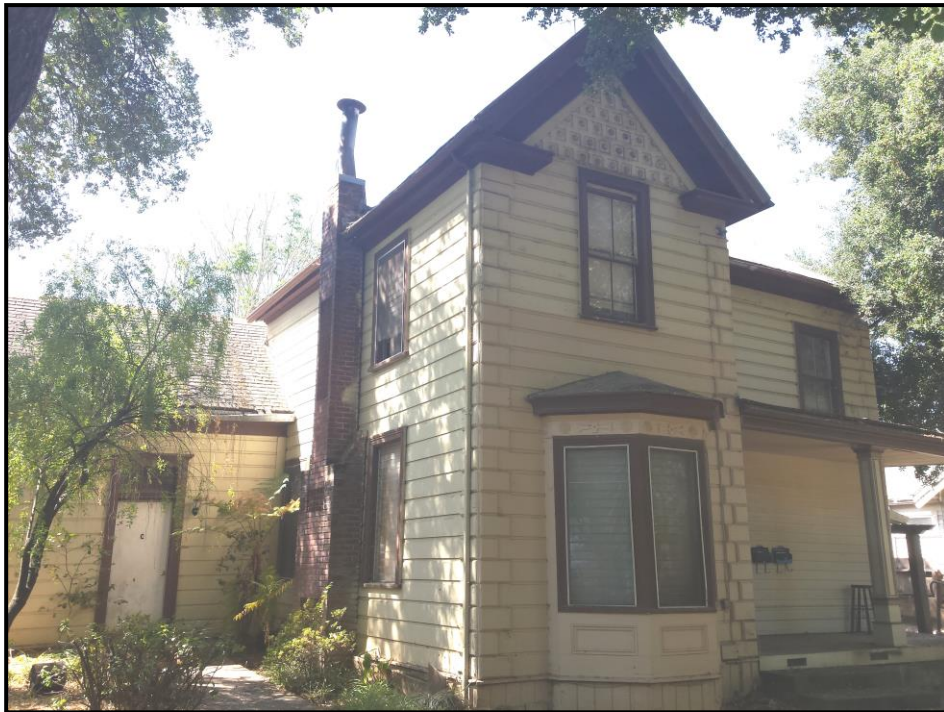
N elevation of medical office addition and E and N elevation of residence, photo view toward SW, 12/2017.

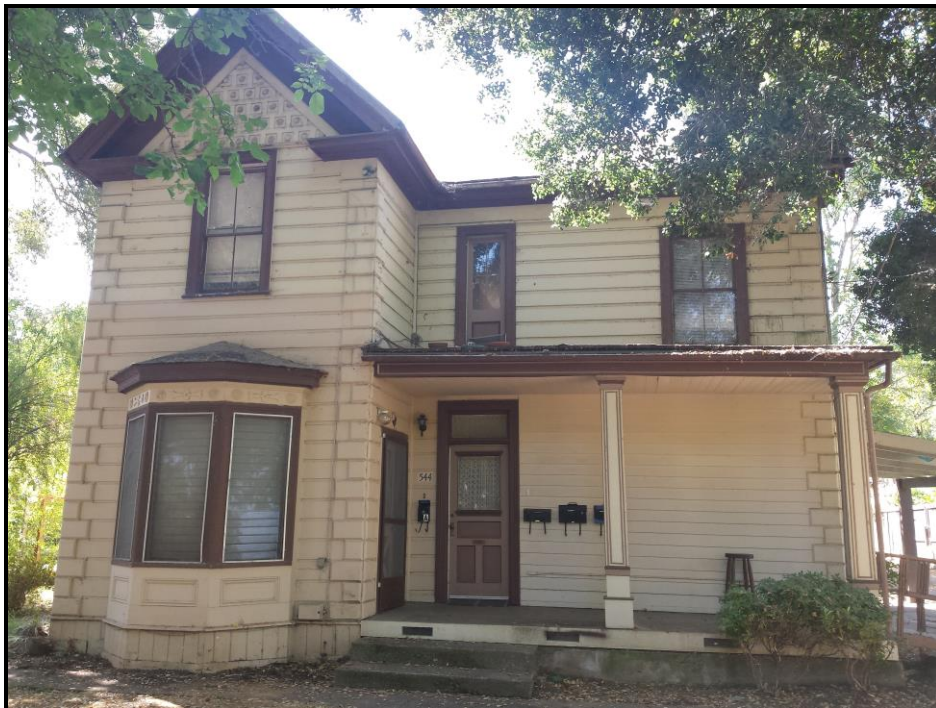
A recessed front porch is set into the apex of the L across the west half of the façade. The porch rests on a separate poured concrete foundation, with two concrete steps in front and an added wheelchair ramp at the west end. This porch has been extensively altered after fire damage; it has a plywood floor and a sagging roof overhang, supported by beaded squared columns not original to the building. A narrow original door, 2/2 lights over a recessed panel, leads out to the second story porch. This porch roof is crooked and rickety, clad with mossy shingles. It has lost its original railings. It is centered just above the original front door with transom. The NW corner of the front elevation was badly damaged by fire in 1981. This section of the building was replaced with new materials. The wood siding surrounding the (original) front door along the west half of the first story is narrower by two inches, not matching the rest of the building. The quoins were replicated to match the other corners of the dwelling, but the siding was not. A new entry door was added perpendicular to the original door when the building was divided into 3 flats in the 1920s.

N elevation of residence, showing door added to the east of original door when house was converted to 3 flats in the 1920s, photo view toward S, 12/2017.

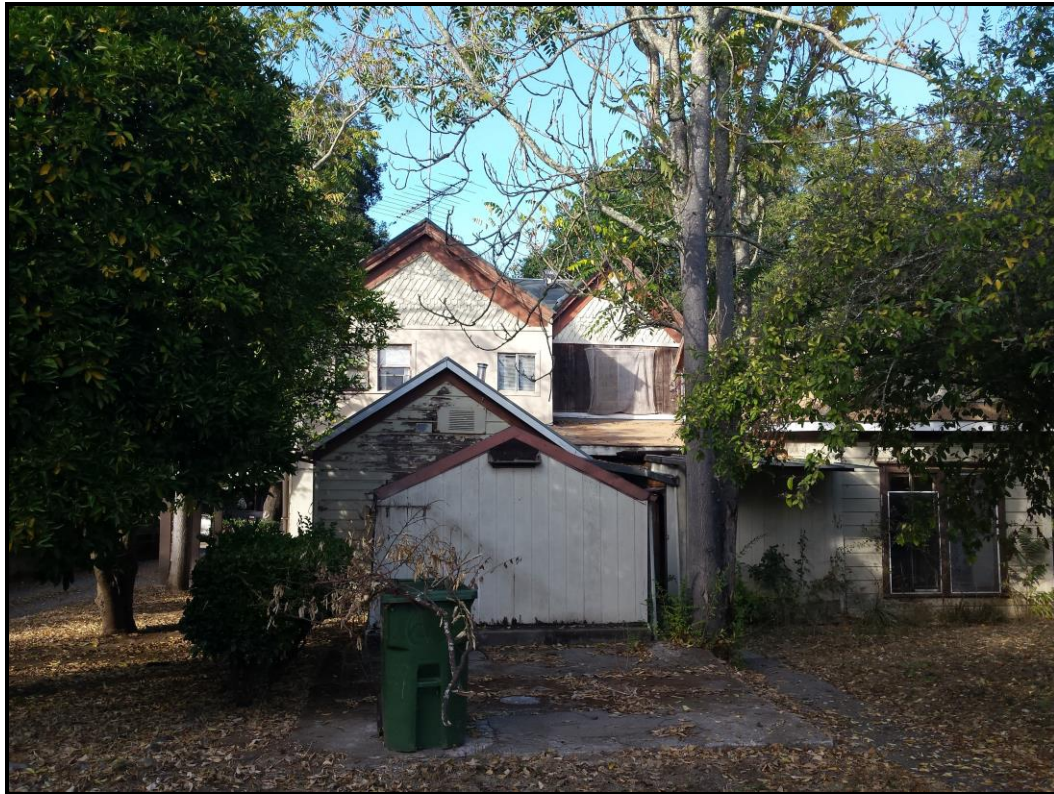
The rear (south) elevation has been greatly altered and is in very poor condition. The multiple additions appear to have been cheaply cobbled together over time with no effort to match the quality, materials, craftsmanship and character of the original dwelling or its 1890s modifications. Two of the rear additions have medium-pitched gable roofs; two of the additions have flat roofs. None of the siding matches the channel rustic of the original. The south wall of the original building has been altered with replacement plywood siding and aluminum windows with simple surrounds that date to the mid-1960s. Below the gable peaks are a few courses of fish scale shingles, part of the Queen Anne embellishments that were added to update and enhance the house in the 1890s. Two of the additions are clad with T-111; one is sided with overlapping composition shingles.

S (rear) elevation with multiple poorly-constructed additions, photo view toward N, 12/2017

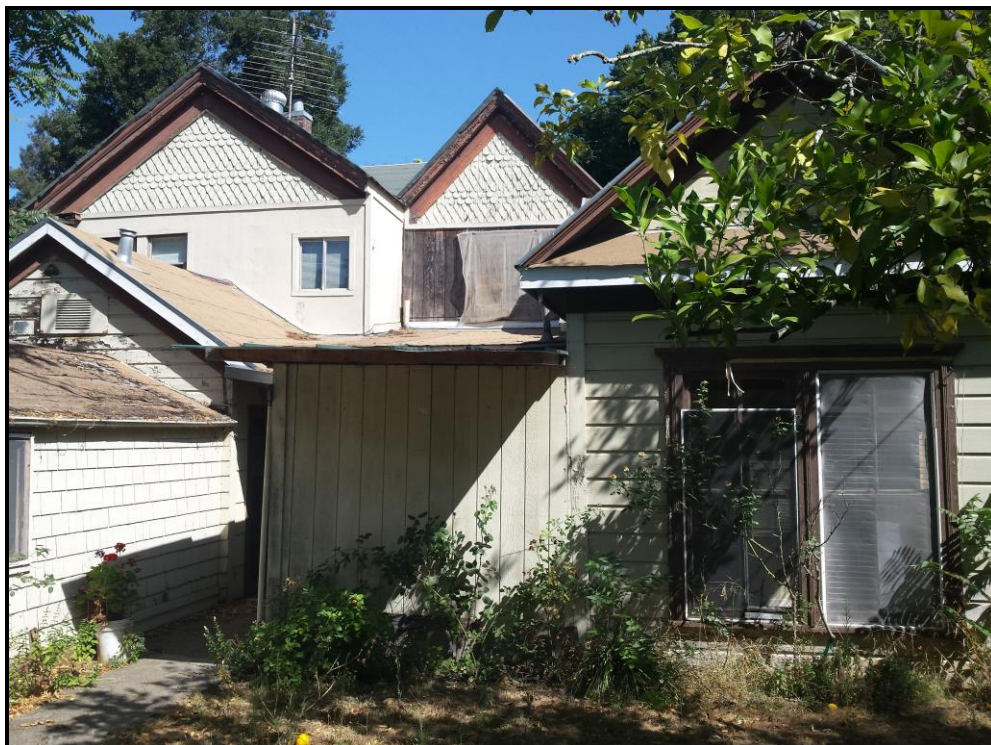
S elevation shows a deteriorated hodgepodge of additions, photo view toward NE, 12/2017.

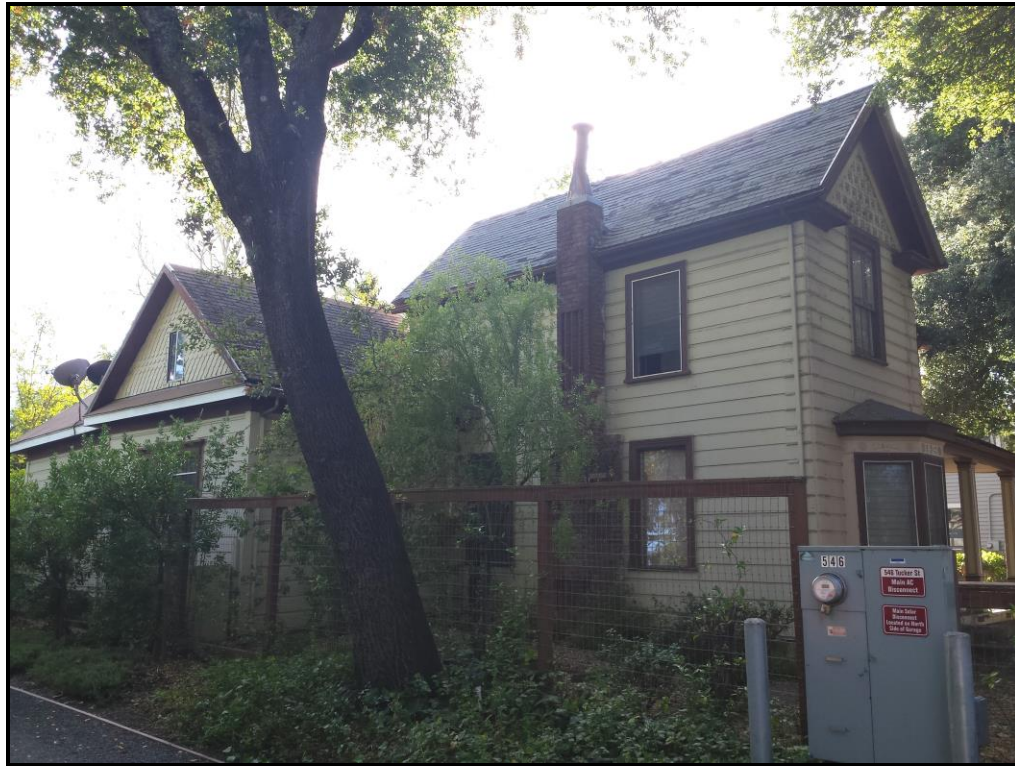
E elevation: The east elevation repeats the channel rustic siding and features three narrow window openings, two on the first story; one on the second story. The original 2/2 windows on this elevation have all been replaced with louvered aluminum replacements. A tall, narrow red brick chimney topped with stovepipe, is interspersed between two windows on the first story. Then brick chimney is damaged and has separated from the exterior wall, leaning out from the side of the building.

A one-story, wood-frame rectangular addition was built onto the SE corner of the residence in the 1890s as a medical office for Dr. Margaret Kimball, the physician who moved to the property in 1889. Later enlarged and converted to residential use in the 1920s, the addition retains the drop siding and fish scale shingles of its construction. The office entrance was centered in the north elevation of the addition. The original front door entrance was dignified with an ornate mantle, multiple lights and a stained glass transom window. The replacement door is plywood. The side gabled roof is decorated with several courses of fish scale shingles under the medium-pitched gable peaks. The battered gutter sags from the mossy shingled roof. The addition lists toward the building without a stable foundation underneath.

E elevation of residence and 1890s doctor's office addition, photo view toward SW, 12/2017

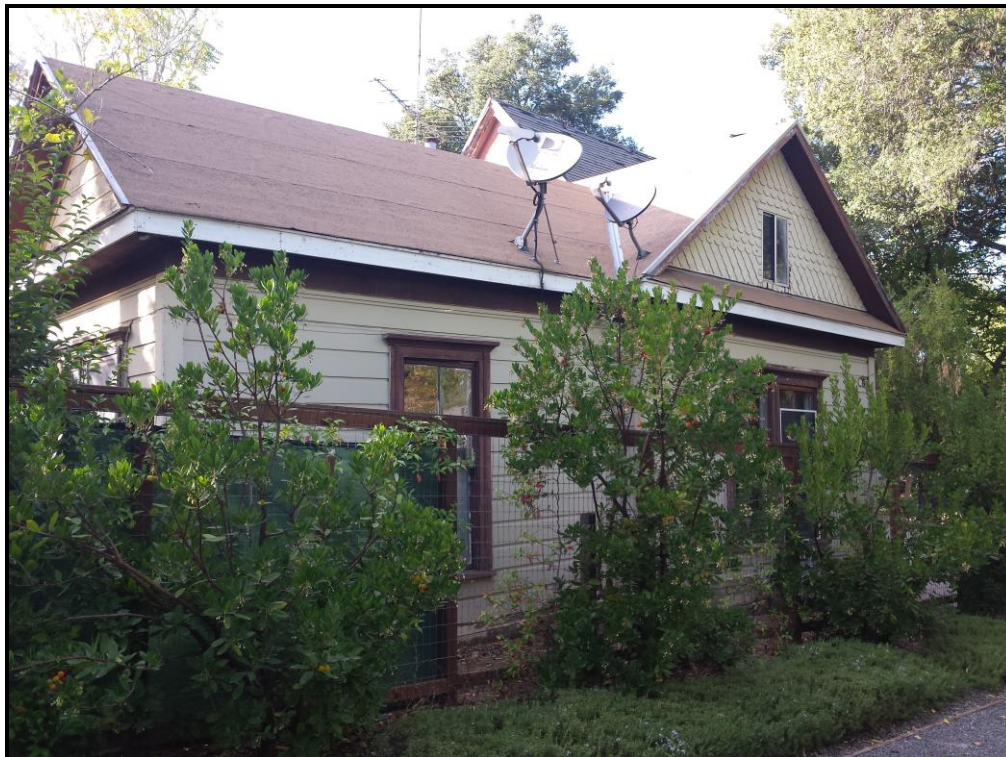
S and E elevations of the cross-gabled later addition to the one-room doctor office, photo view toward NW

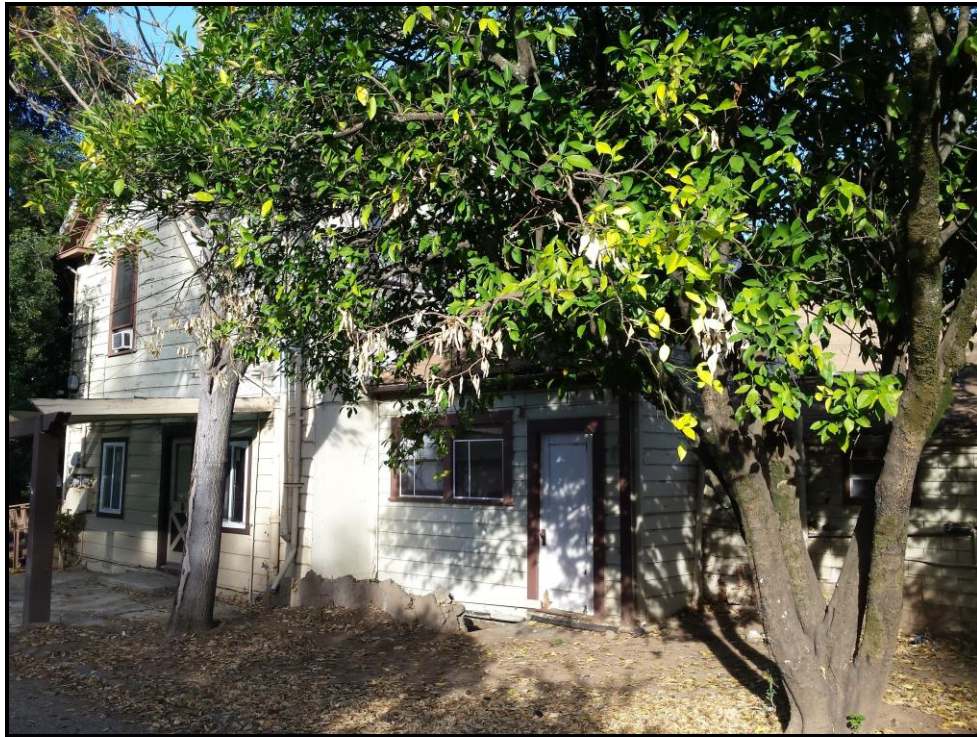
The west side of the building is partially visible from the street. The cross gabled roofline features the same steeply pitched gable with gable returns that is seen on the front (N elevation). Below the gable peak are five courses of bull's eyes that match those on the front of the dwelling. There are two window openings on the first story, but the original 2/2 windows have been replaced by inappropriate wooden sliders. A new doorway has been added between the replacement windows. The 2/2 double hung wood sash window on the second story has been replaced by a louvered aluminum window. The channel rustic siding shows damage from the removal of an arbor that once grew against the house.

W elevation of residence and additions, photo view toward NE, 12/2017

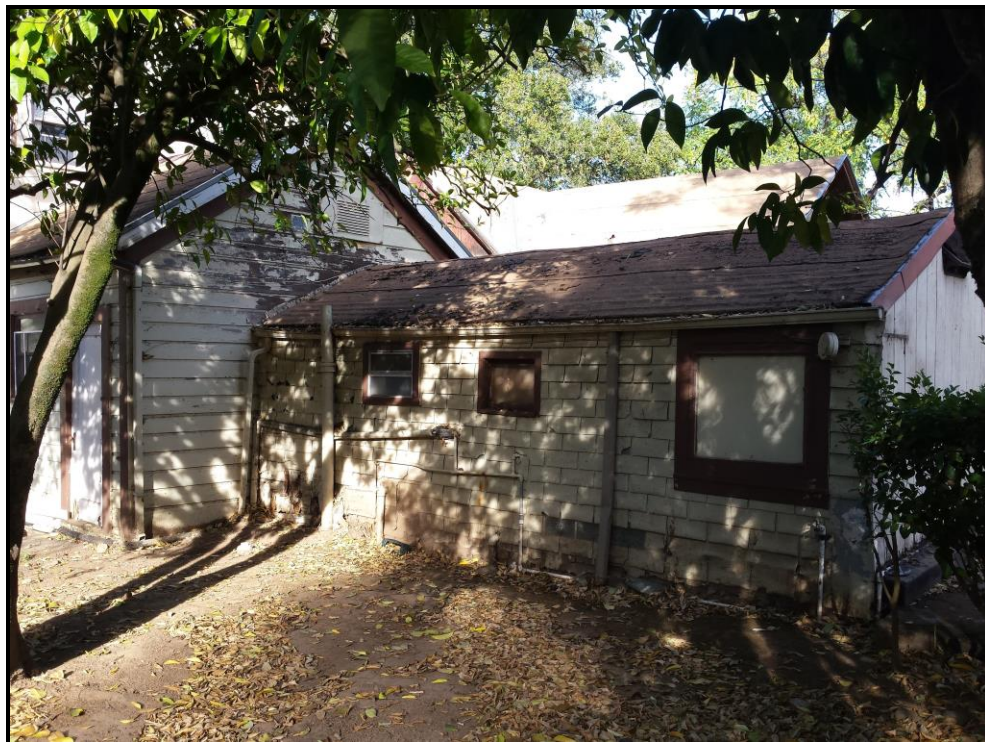
The entire south elevation consists of multiple very poor quality and cheaply constructed additions that appear to have been built from salvaged materials without permits or skill in early 1960s-1970s. The T-111 siding particularly detracts from the historic appearance of the building. Historic photos from the turn of the 20<sup>th</sup> century show that the front of the house boasted white picket fencing with handsome turned posts and a set of wooden steps next to the street for convenient mounting and dismounting from a horse-drawn carriage. Site records show a two-story barn and outbuildings were located at the back of the lot for most of the house's history, separated from the main house by an orchard, poultry yard and garden. A tank house and windmill were located directly behind the house.

Close up of W and S elevations of additions on W side of residence, photo view toward NE, 12/2017.

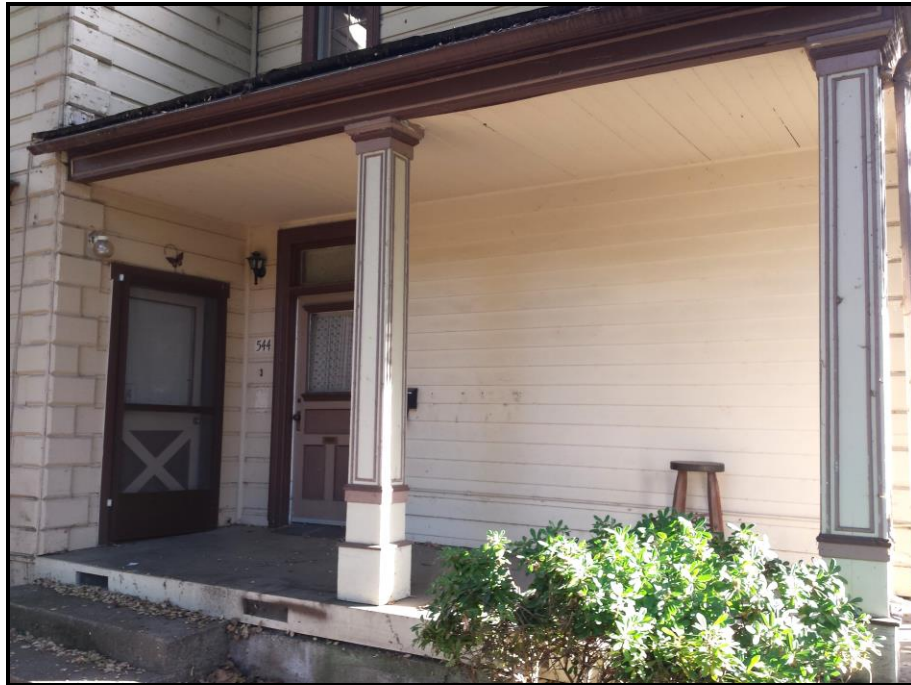
Front porch shows major alterations in design and materials after conversion to apartments and subsequent fire damage; photo view toward SE, 12/2017

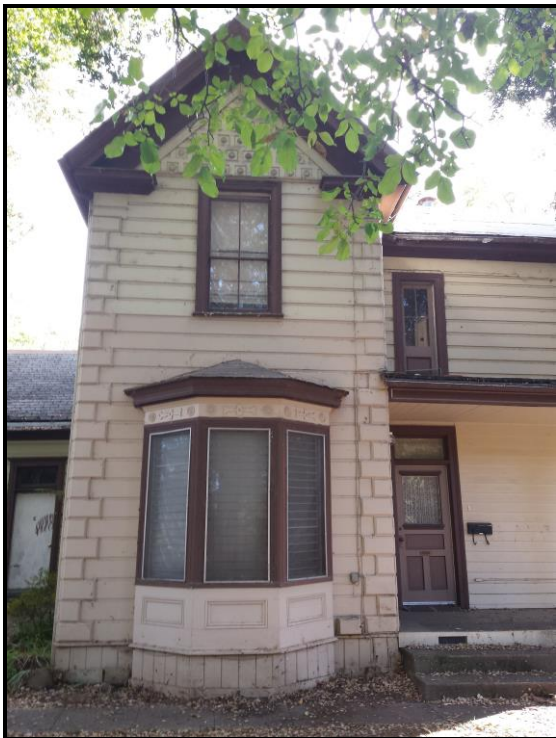
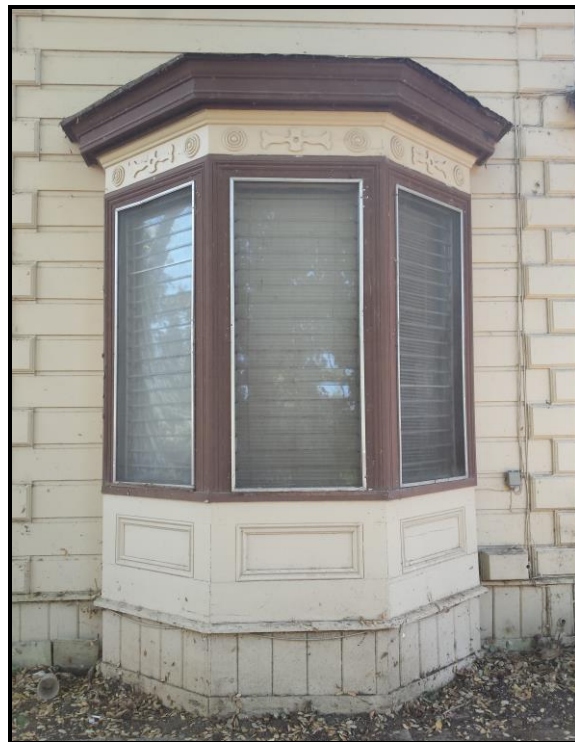
The original L-shaped volume of the house is centered beneath a steeply-pitched front gable roof with gable returns. Several courses of decorative bulls' eyes have been applied below the gable peak, likely at a later time. This section of the building is clad with 8" channel rustic siding and features quoins at the corners, which are emphasized with contrasting paint color that matches the dark window trim. A single 2/2 double-hung wood sash window is set in the middle of the second story. Directly below it on the first story is a canted bay window with three lights. The window is decorated with molded panels below the lights and molded ornaments above. The windows in the bay are aluminum louvered replacements.

Close-up of the N elevation façade character-defining elements: quoins, verticality, 2/2 windows, narrow doors with transom, steeply pitched gable roof and sharp gable returns, bull's eyes under gable peak, canted bay window with ornamental details; Close-up of canted bay window replaced on N elevation, 12/2017

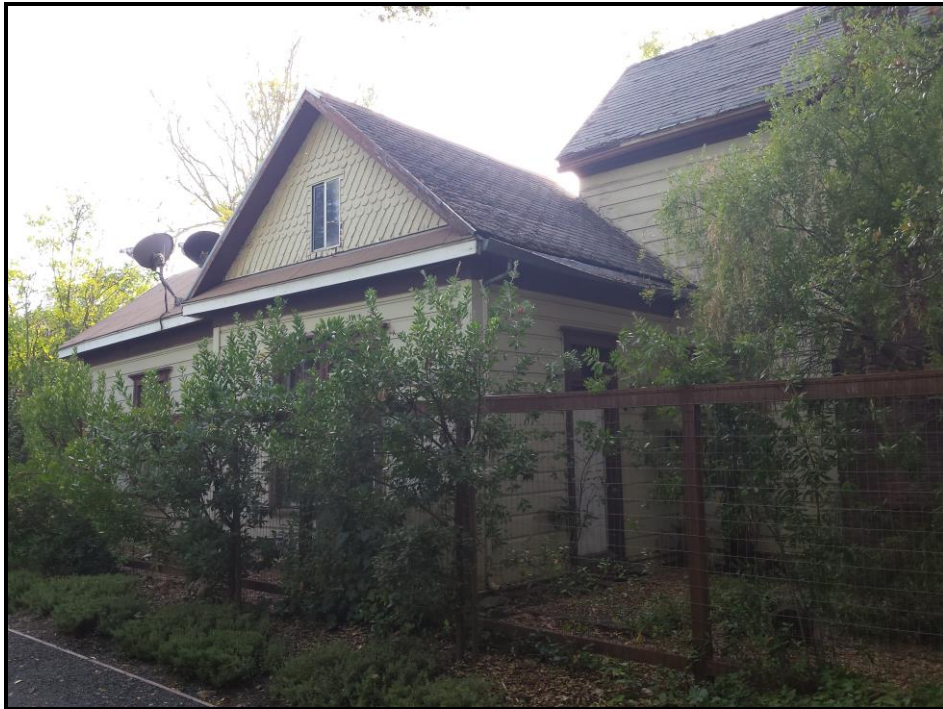
E and N elevations of 1890s doctor office addition with a later cross-gabled S addition that matched the previous quality of windows and siding, but not fish scale shingles; photo view toward SW, 12/2017

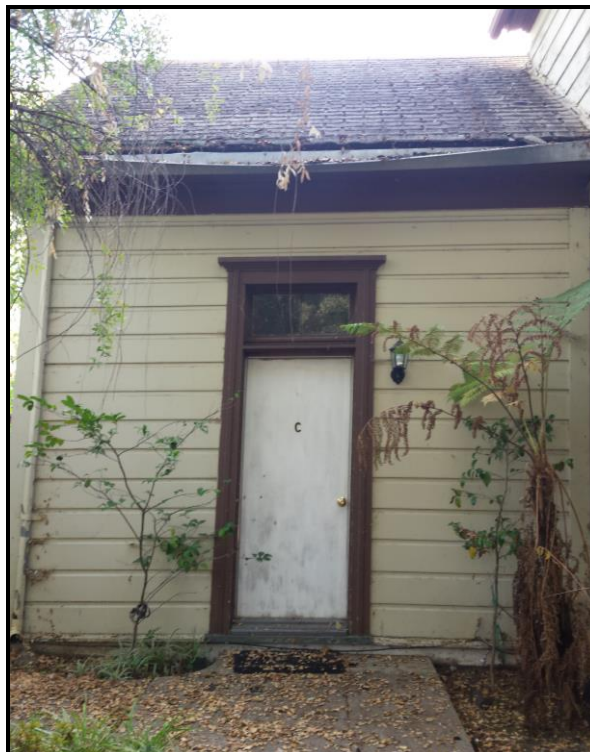
Close up of (N) entrance to office addition on E side of residence. It retains original siding, door frame and transom with inappropriate replacement door; roof and foundation damage, photo view toward S, 12/2017.

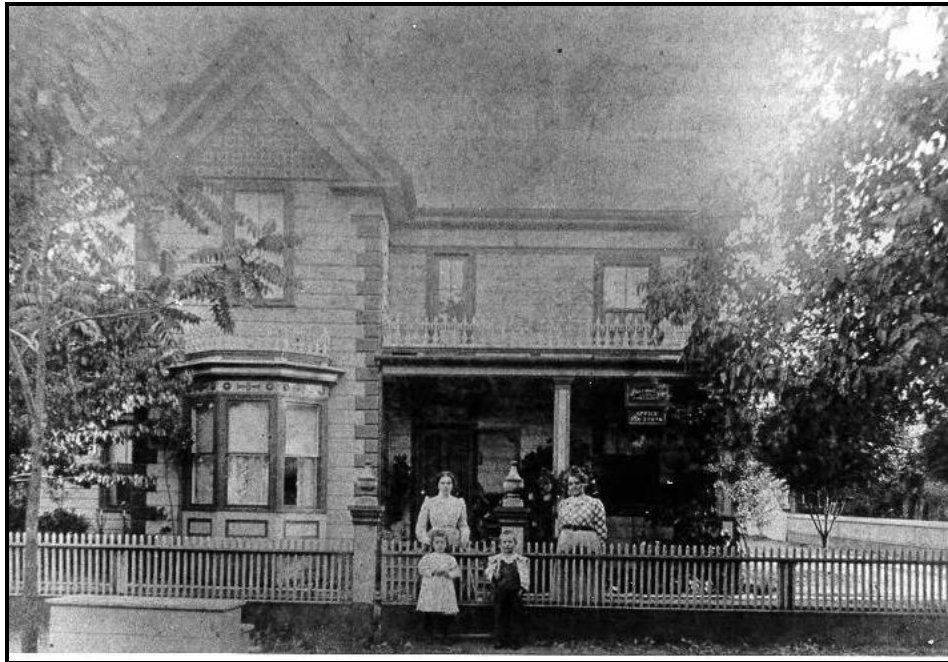
1899 Kimball family at Kimball Residence, N elevation. Photo view toward S.

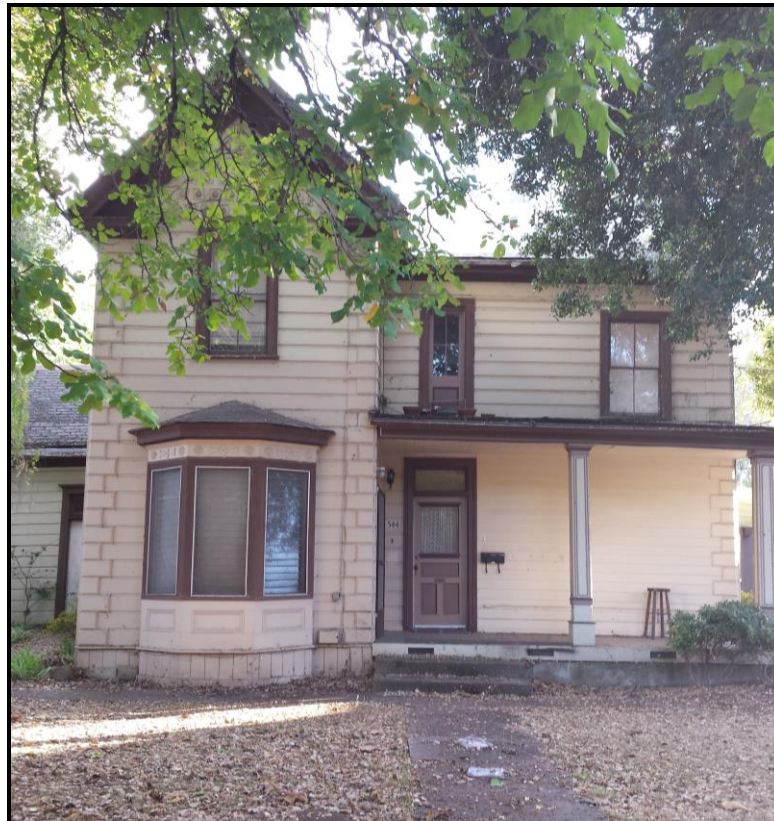
December 2017 Residence, N elevation. Photo view toward S.
