**GEOTECHNICAL INVESTIGATION
QUAKER HILL PROPERTY
HEALDSBURG, CALIFORNIA**

PROJECT NO. 20181540.001A

September 15, 2017

A Report Prepared for:

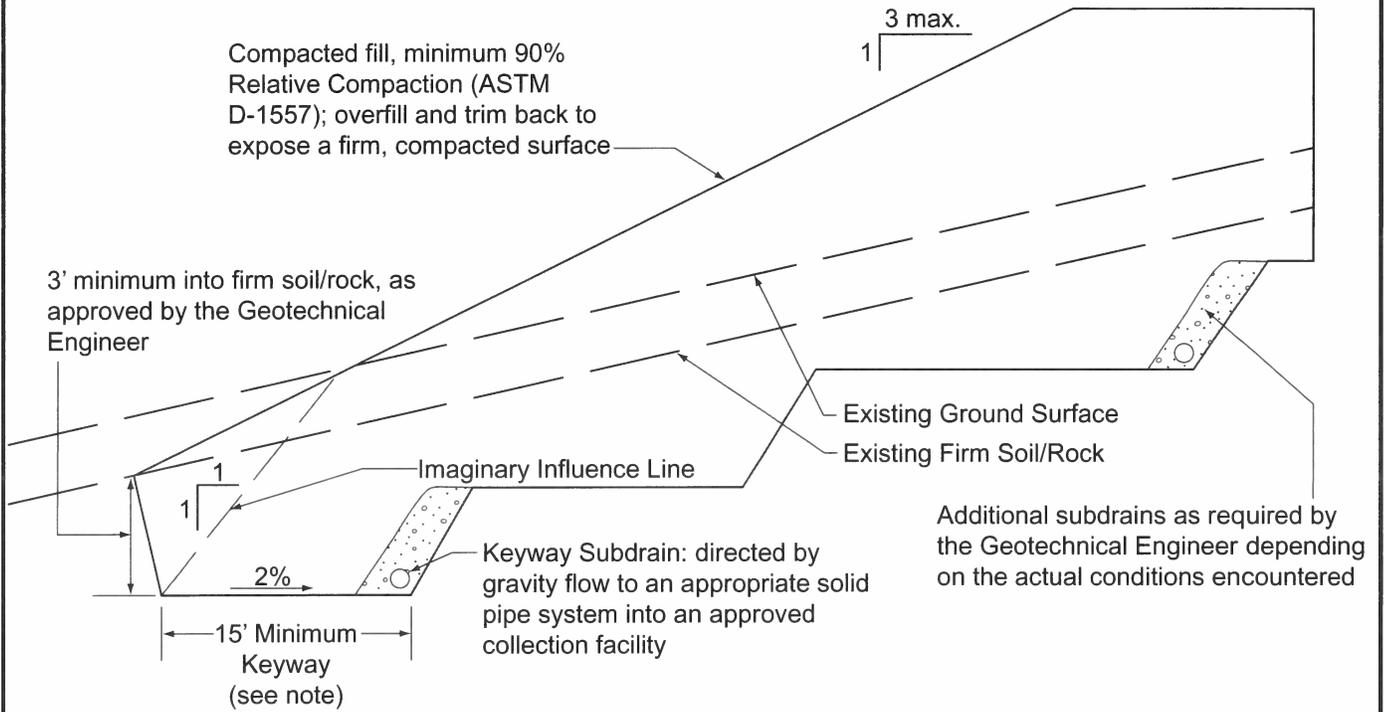
Typical Fill Section - Keyway Construction
(not to scale)

Note: Keyway excavation and subdrain installation should be observed by the Geotechnical Engineer; where existing slope exceeds 6H:1V (Horizontal:Vertical), excavate series of benches into firm soil/rock, as indicated below.

- Figure 1 Site Location
- Figure 2 Conceptual Development Plan
- Figure 3 Site Plan and Geologic Map
- Figure 4 Area Geology
- Figure 5 Typical Fill Slope and Subdrain Details
- Figure 6 Retaining Wall Backfill and Drainage Detail

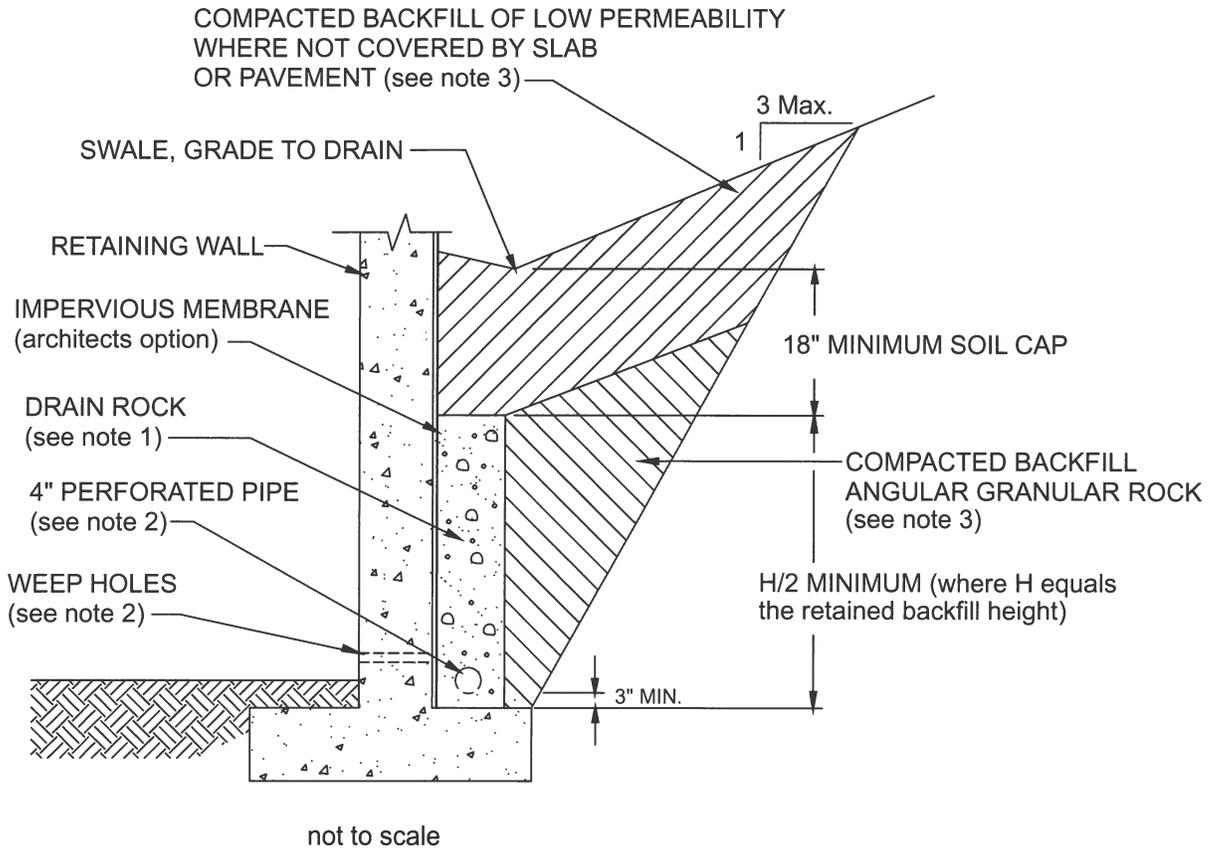
1. Drain rock should be clean, free draining 3/4 inch crushed rock or gravel wrapped in filter fabric (Mirafi 140N or equivalent) or Class 2 Permeable Material, Section 68, State of California "Caltrans" Standard Specification, latest edition. Alternatively, a pre-fabricated drainage structure (Miradrain or equivalent) installed to the manufacturers recommendations, may be used in lieu of drainrock and fabric.

3. During compaction, the contractor should use appropriate methods (such as temporary bracing and/or light compaction equipment) to avoid overstressing the walls.

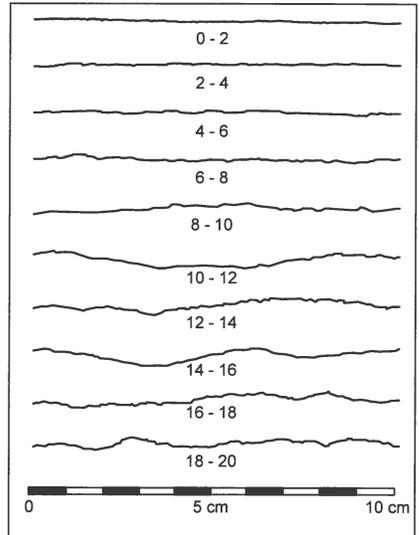
JOINT ROUGHNESS COEFFICIENT (JRC)

From Barton and Choubey, 1977

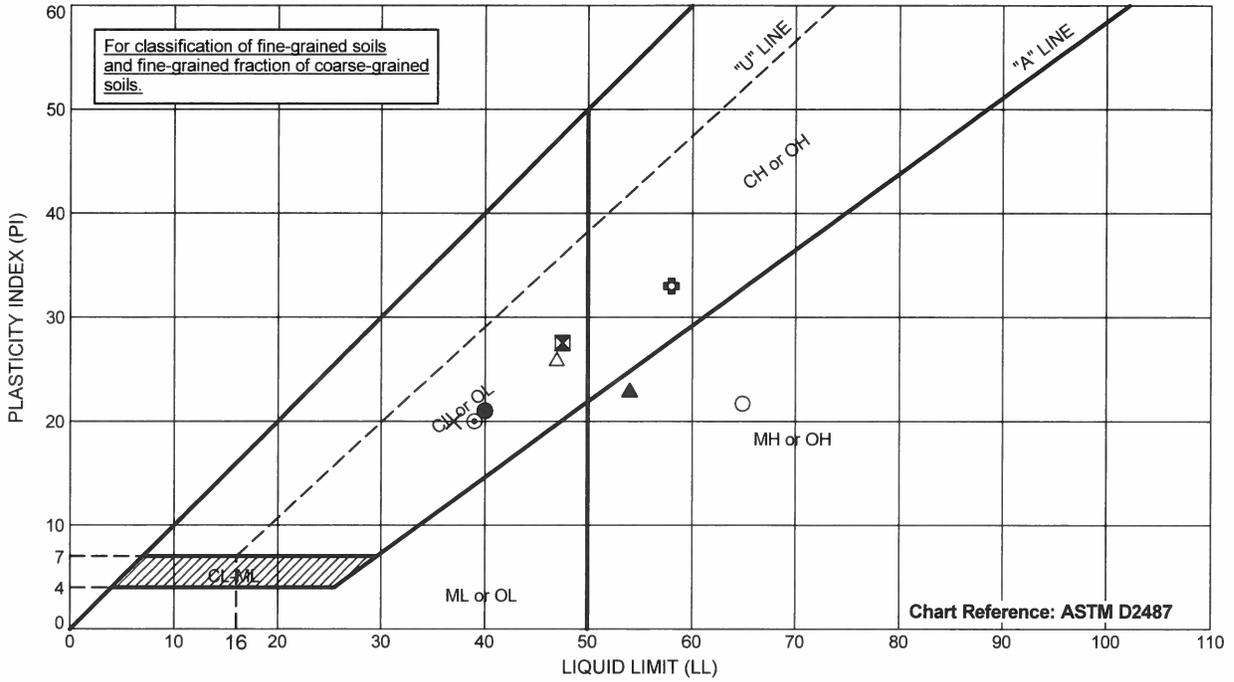
Exploration ID	Depth (ft.)	Sample Description	Passing #200	LL	PL	PI
● KB-1	2.5	OLIVE BROWN SANDY LEAN CLAY (CL)	NM	40	19	21
⊠ KB-4	1	OLIVE BROWN SANDY LEAN CLAY (CL)	NM	48	20	28
▲ KB-5/6	0 - 6	OLIVE BROWN SANDY ELASTIC SILT (MH)	NM	54	31	23
⊗ KB-7	2	DARK YELLOWISH BROWN CLAYEY SAND WITH GRAVEL (SC)	NM	37	17	20
⊙ KB-10	2	DARK OLIVE BROWN CLAYEY SAND WITH GRAVEL (SC)	27	39	19	20
⊕ KB-11	2	DARK OLIVE BROWN CLAYEY SAND (SC)	37	58	25	33
○ KB-13	3	DARK GREENISH GRAY SERPENTINITE	NM	65	43	22
△ KB-14	3	DARK OLIVE BROWN CLAYEY GRAVEL WITH SAND (GC)	24	47	21	26

Testing performed in general accordance with ASTM D4318.
 NP = Nonplastic
 NM = Not Measured

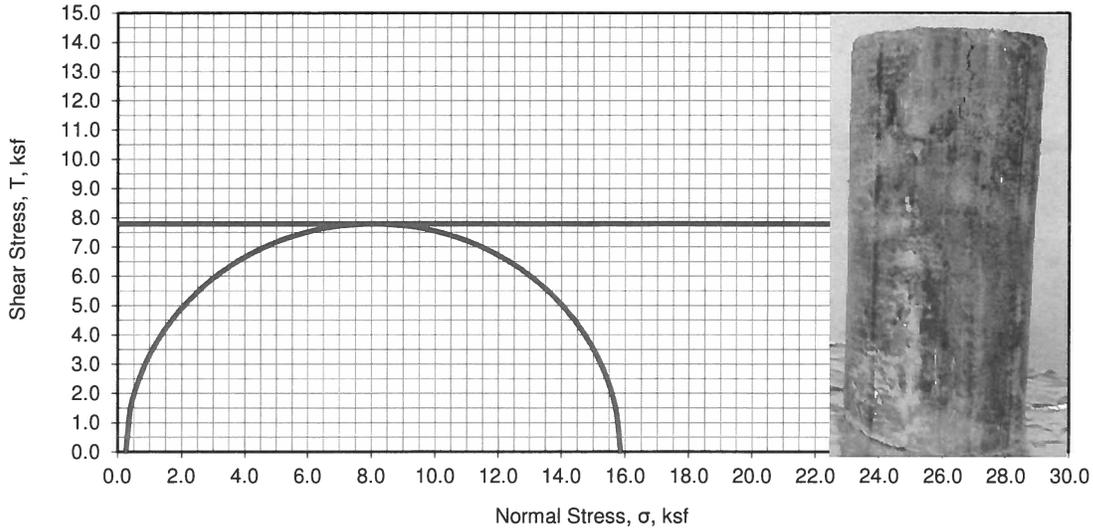
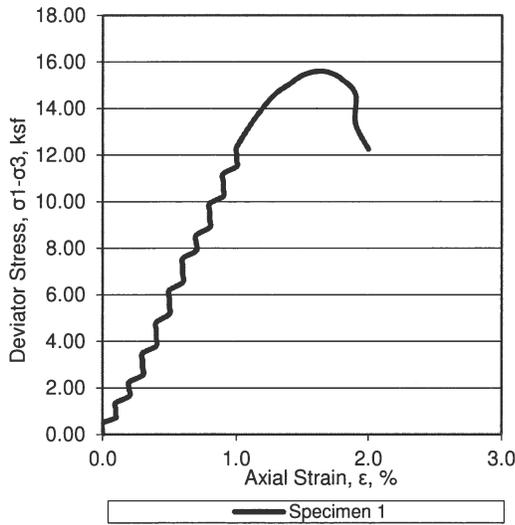
Figure
 1 of 1
B-3

Total	
c =	7.79 ksf

Specimen No.		1	
Initial	Diameter, in	D _o	2.41
	Height, in	H _o	5.53
	Water Content, %	ω _o	12.3
	Dry Density, lbs/ft ³	γ _d _o	120.2
	Saturation, %	S _o	87
	Void Ratio	e _o	0.375
Minor Principal Stress, ksf		σ ₃	0.25
Maximum Deviator Stress, ksf		(σ ₁ -σ ₃) _{max}	15.59
Time to (σ ₁ -σ ₃) _{max} , min		t _f	1.63
Deviator Stress @ 15% Axial Strain, ksf		(σ ₁ -σ ₃) _{15%}	12.25
Ultimate Deviator Stress, ksf		(σ ₁ -σ ₃) _{ult}	na
Rate of strain, %/min		ε̇	1.00
Axial Strain at Failure, %		ε _f	1.63

Description of Specimen: Dark Grayish Brown Lean Clay with Sand (CL)			
Amount of Material Finer than the No. 200, %:		nm	
LL: nm	PL: nm	PI: nm	G _s : 2.65 Assumed
Specimen Type: Undisturbed		Test Method: ASTM D2850

The results of dry density and moisture content testing along with the results of the strength tests are shown on the boring logs adjacent to the samples tested.

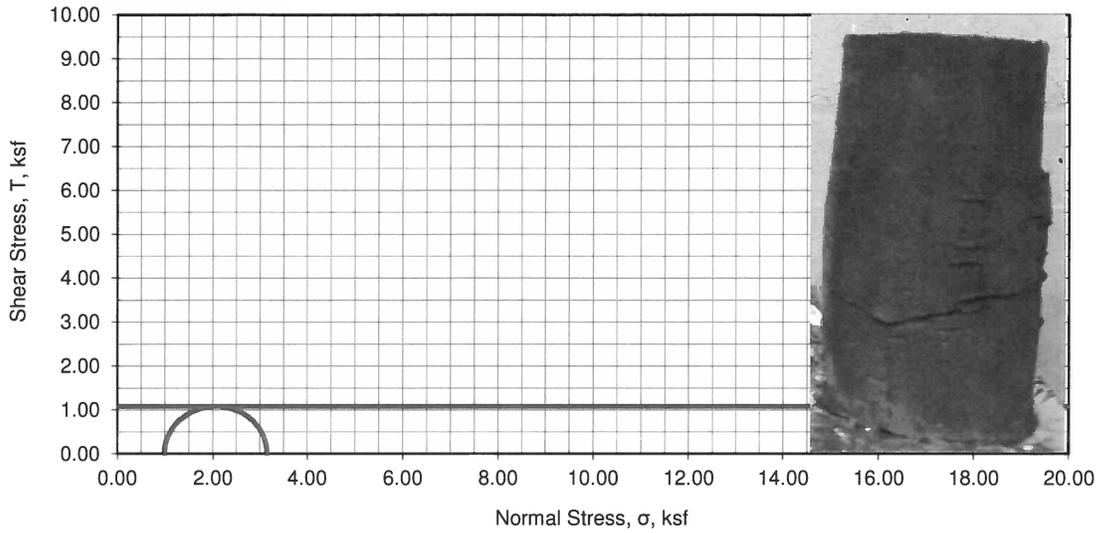
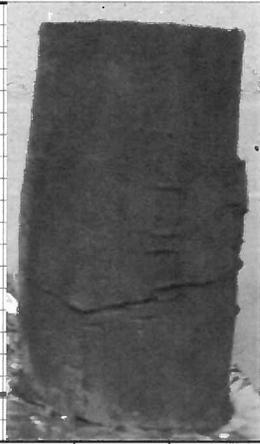
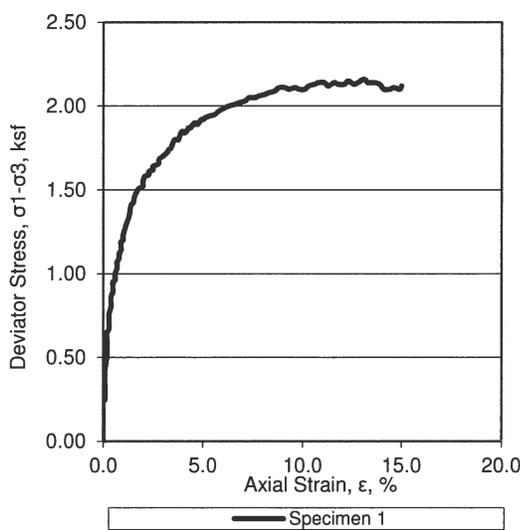
Project No.:	20181540	TRIAXIAL COMPRESSION TEST (UU)	Figure 1 of 1
	Date:	8/25/17		
	Entry By:	CP	Quaker Hill 32 Acre Parcel Healdsburg, California	B-4
	Checked By:	CP		
File Name:	HL10476

Total	
c =	1.08 ksf

Specimen No.		1	
Initial	Diameter, in	D _o	2.40
	Height, in	H _o	5.61
	Water Content, %	w _o	30.6
	Dry Density, lbs/ft ³	γ _d _o	90.0
	Saturation, %	S _o	97
	Void Ratio	e _o	0.838
Minor Principal Stress, ksf		σ ₃	0.99
Maximum Deviator Stress, ksf		(σ ₁ -σ ₃) _{max}	2.16
Time to (σ ₁ -σ ₃) _{max} , min		t _f	13.08
Deviator Stress @ 15% Axial Strain, ksf		(σ ₁ -σ ₃) _{15%}	2.12
Ultimate Deviator Stress, ksf		(σ ₁ -σ ₃) _{ult}	na
Rate of strain, %/min		'ε	1.00
Axial Strain at Failure, %		ε _f	13.08

Description of Specimen:		Black Sandy Lean Clay (CL)	
Amount of Material Finer than the No. 200, %:		nm	
LL: nm	PL: nm	PI: nm	G _s : 2.65 Assumed
Specimen Type:		Undisturbed	
Test Method:		ASTM D2850

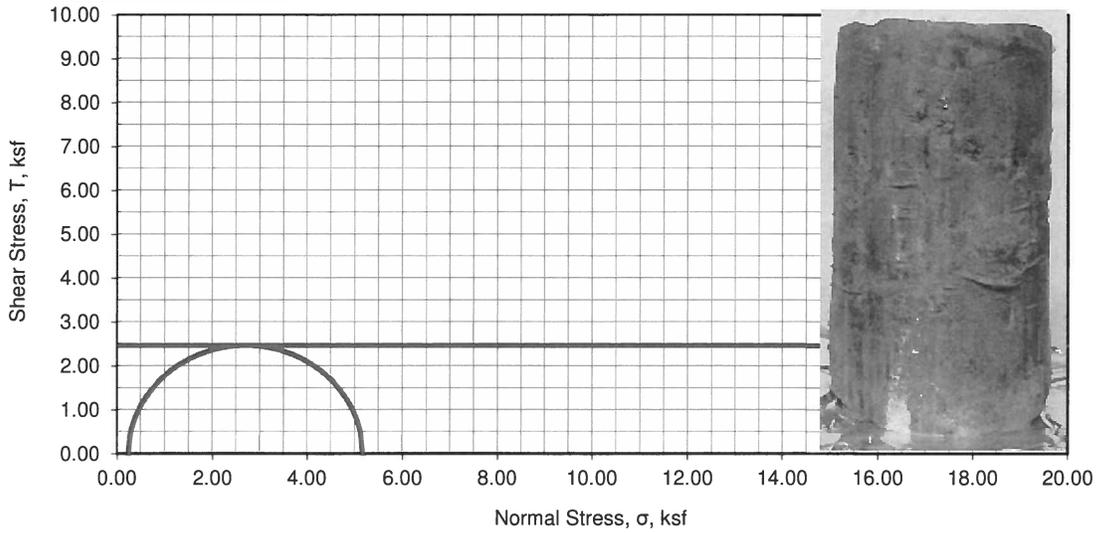
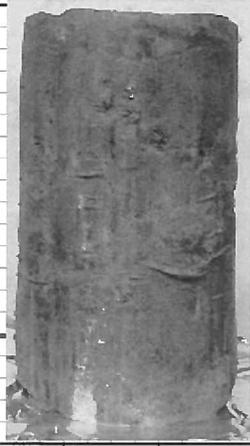
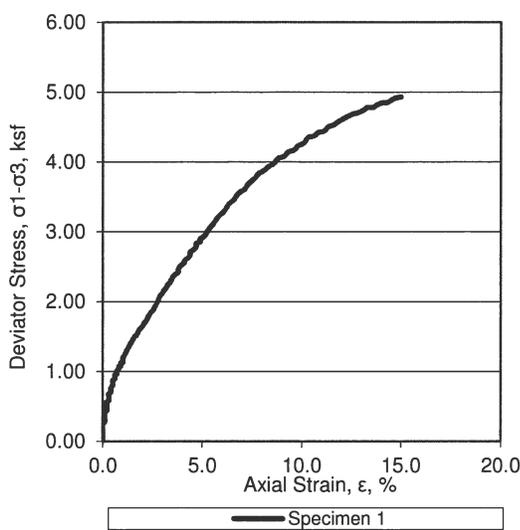
<p>KLEINFELDER Bright People. Right Solutions. 2601 Barrington Ct, Hayward, CA 94545</p>	Project No.:	20181540	TRIAXIAL COMPRESSION	Figure 1 of 1
	Date:	8/25/17		
	Entry By:	CP	Quaker Hill 32 Acre Parcel Healdsburg, California	B-5
	Checked By:	CP		
File Name:	HL10476

Total	
c =	2.46 ksf

Specimen No.		1
Initial	Diameter, in	D _o 2.40
	Height, in	H _o 5.51
	Water Content, %	w _o 12.1
	Dry Density, lbs/ft ³	γ _d 121.2
	Saturation, %	S _o 88
	Void Ratio	e _o 0.364
Minor Principal Stress, ksf		σ ₃ 0.24
Maximum Deviator Stress, ksf		(σ ₁ -σ ₃) _{max} 4.93
Time to (σ ₁ -σ ₃) _{max} , min		t _f 15.02
Deviator Stress @ 15% Axial Strain, ksf		(σ ₁ -σ ₃) _{15%} 4.93
Ultimate Deviator Stress, ksf		(σ ₁ -σ ₃) _{ult} na
Rate of strain, %/min		ε̇ 1.00
Axial Strain at Failure, %		ε _f 15.02

Description of Specimen:		Dark Yellowish Brown Clayey Sand with Gravel (SC)	
Amount of Material Finer than the No. 200, %:		nm	
LL: 37	PL: 17	PI: 20	G _s : 2.65 Assumed
Specimen Type:		Undisturbed	Test Method: ASTM D2850

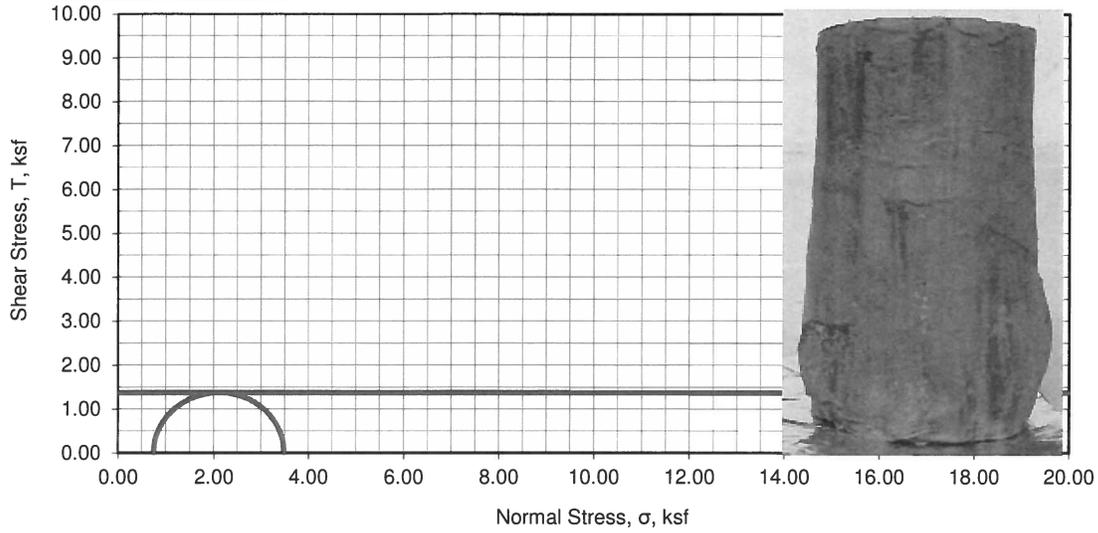
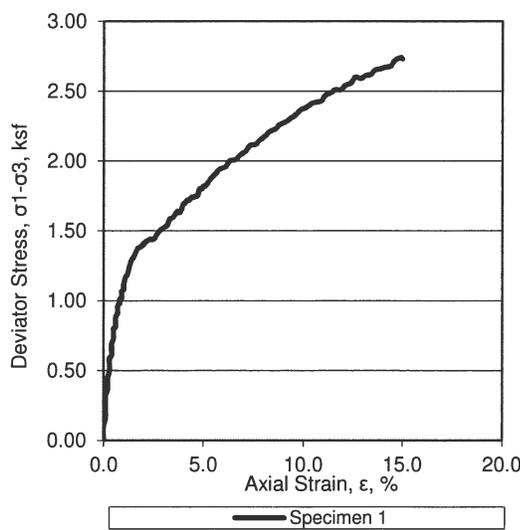
Figure
1 of 1
B-6

Total	
c =	1.37 ksf

Specimen No.		1
Initial	Diameter, in	D _o 2.40
	Height, in	H _o 5.59
	Water Content, %	ω _o 70.2
	Dry Density, lbs/ft ³	γ _d _o 54.4
	Saturation, %	S _o 91
	Void Ratio	e _o 2.042
Minor Principal Stress, ksf		σ ₃ 0.75
Maximum Deviator Stress, ksf		(σ ₁ -σ ₃) _{max} 2.74
Time to (σ ₁ -σ ₃) _{max} , min		t _f 14.88
Deviator Stress @ 15% Axial Strain, ksf		(σ ₁ -σ ₃) _{15%} 2.73
Ultimate Deviator Stress, ksf		(σ ₁ -σ ₃) _{ult} na
Rate of strain, %/min		'ε 1.00
Axial Strain at Failure, %		ε _f 14.88

Description of Specimen: Olive Brown Sandy Lean Clay (CL)			
Amount of Material Finer than the No. 200, %: nm			
LL: nm	PL: nm	PI: nm	G _s : 2.65 Assumed
Specimen Type: Undisturbed		Test Method: ASTM D2850

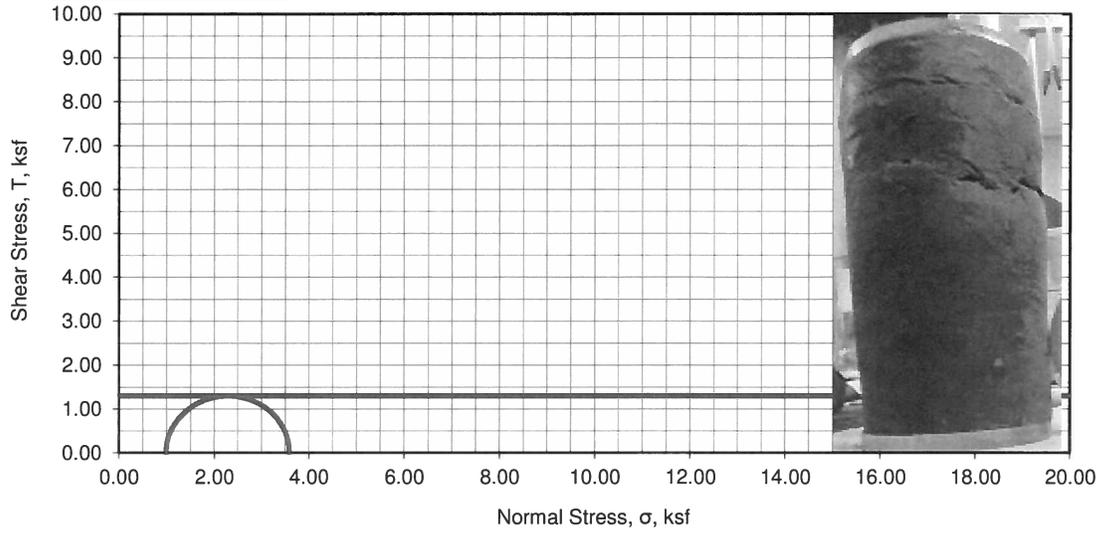
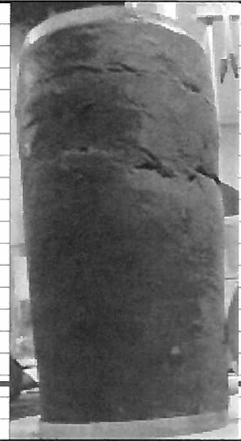
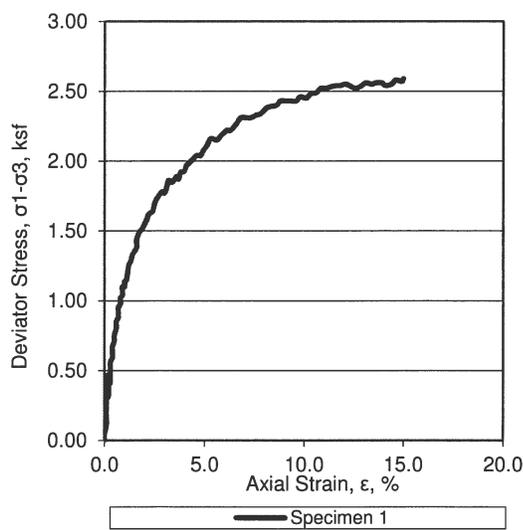
Figure
1 of 1
B-7

Total	
c =	1.30 ksf

Specimen No.			1
Initial	Diameter, in	D _o	2.40
	Height, in	H _o	5.76
	Water Content, %	w _o	23.2
	Dry Density, lbs/ft ³	γ _{d_o}	98.8
	Saturation, %	S _o	91
	Void Ratio	e _o	0.673
Minor Principal Stress, ksf		σ ₃	0.99
Maximum Deviator Stress, ksf		(σ ₁ -σ ₃) _{max}	2.59
Time to (σ ₁ -σ ₃) _{max} , min		t _f	15.00
Deviator Stress @ 15% Axial Strain, ksf		(σ ₁ -σ ₃) _{15%}	2.59
Ultimate Deviator Stress, ksf		(σ ₁ -σ ₃) _{ult}	na
Rate of strain, %/min		ε̇	1.00
Axial Strain at Failure, %		ε _f	15.00

Description of Specimen:		Brown Lean Clay (CL)	
Amount of Material Finer than the No. 200, %:		nm	
LL: nm	PL: nm	PI: nm	G _s : 2.65 Assumed
Specimen Type:		Undisturbed	Test Method: ASTM D2850

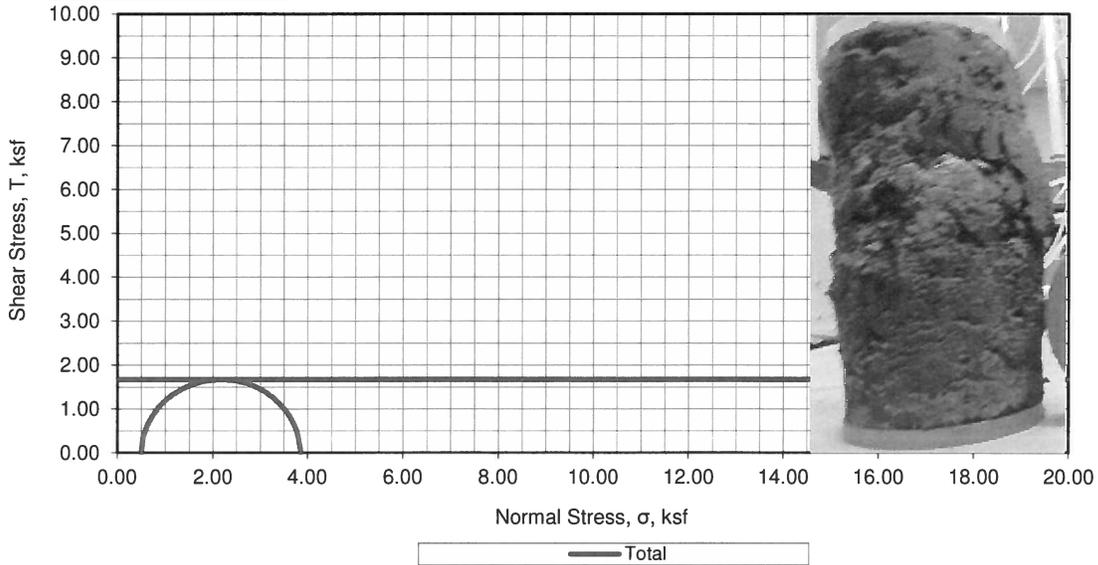
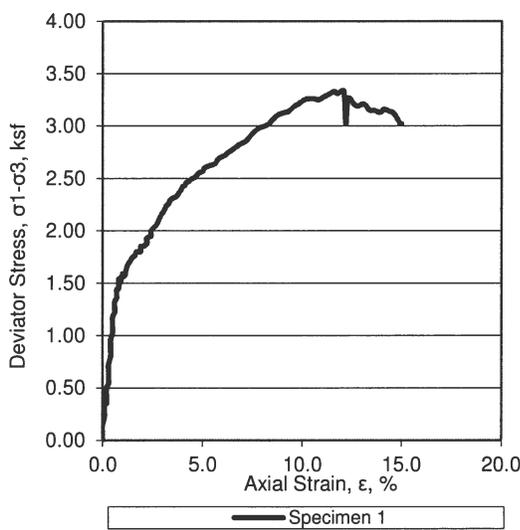
Project No.:	20181540	TRIAxIAL COMPRESSION TEST (UU) Quaker Hill 32 Acre Parcel Healdsburg, California	Figure 1 of 1 B-8
	Date:	9/6/17		
	Entry By:	CP		
	Checked By:	CP		
	File Name:	HL10523

Total	
c =	1.67 ksf

Specimen No.		1
Initial	Diameter, in	D ₀ 2.39
	Height, in	H ₀ 5.60
	Water Content, %	ω ₀ 10.0
	Dry Density, lbs/ft ³	γ _{d0} 122.9
	Saturation, %	S ₀ 77
	Void Ratio	e ₀ 0.346
Minor Principal Stress, ksf		σ ₃ 0.50
Maximum Deviator Stress, ksf		(σ ₁ -σ ₃) _{max} 3.33
Time to (σ ₁ -σ ₃) _{max} , min		t _f 12.10
Deviator Stress @ 15% Axial Strain, ksf		(σ ₁ -σ ₃) _{15%} 3.02
Ultimate Deviator Stress, ksf		(σ ₁ -σ ₃) _{ult} na
Rate of strain, %/min		'ε 1.00
Axial Strain at Failure, %		ε _f 12.10

Description of Specimen: Brown Sandy Lean Clay (CL)			
Amount of Material Finer than the No. 200, %: nm			
LL: nm	PL: nm	PI: nm	G _s : 2.65 Assumed
Specimen Type: Undisturbed		Test Method: ASTM D2850

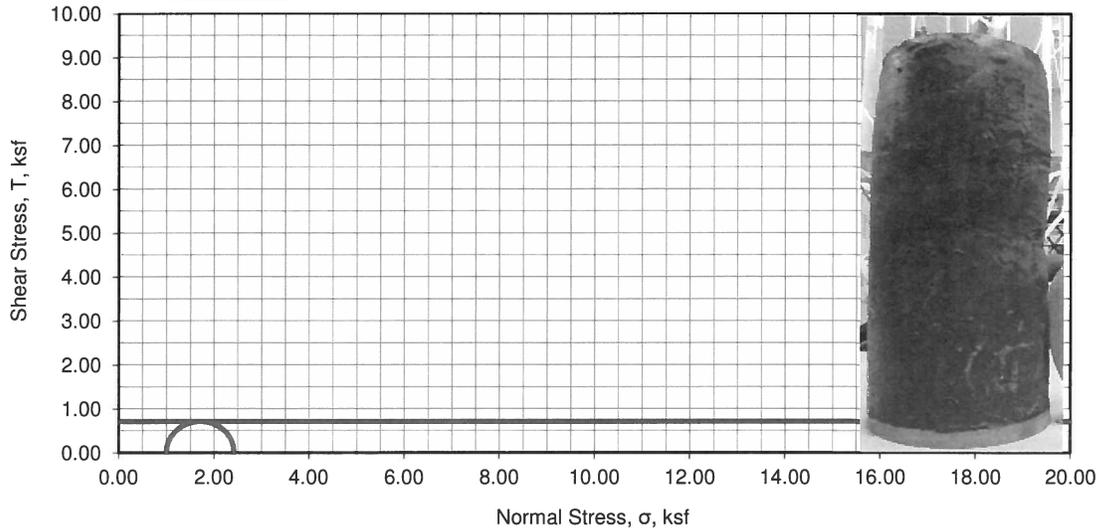
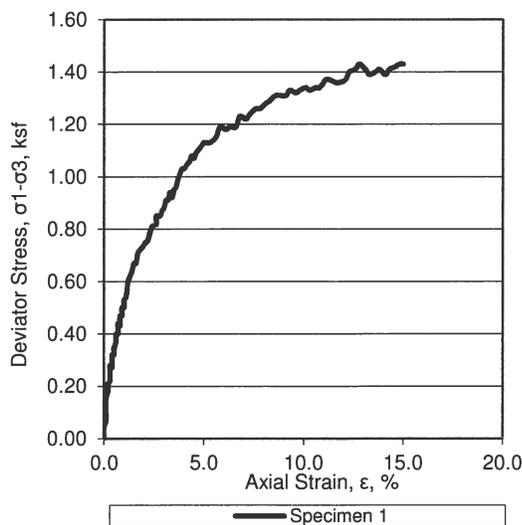
<p>KLEINFELDER Bright People. Right Solutions. 2601 Barrington Ct, Hayward, CA 94545</p>	Project No.:	20181540	TRIAXIAL COMPRESSION TEST (UU)	Figure 1 of 1
	Date:	9/6/17		
	Entry By:	CP	Quaker Hill 32 Acre Parcel Healdsburg, California	B-9
	Checked By:	CP		
	File Name:	HL10523

Total	
c =	0.71 ksf

Specimen No.		1
Initial	Diameter, in	D _o 2.40
	Height, in	H _o 5.86
	Water Content, %	w _o 24.4
	Dry Density, lbs/ft ³	γ _d 101.2
	Saturation, %	S _o 102
	Void Ratio	e _o 0.634
Minor Principal Stress, ksf		σ ₃ 0.99
Maximum Deviator Stress, ksf		(σ ₁ -σ ₃) _{max} 1.43
Time to (σ ₁ -σ ₃) _{max} , min		t _f 14.85
Deviator Stress @ 15% Axial Strain, ksf		(σ ₁ -σ ₃) _{15%} 1.43
Ultimate Deviator Stress, ksf		(σ ₁ -σ ₃) _{ult} na
Rate of strain, %/min		'ε 1.00
Axial Strain at Failure, %		ε _f 14.85

Description of Specimen: Brown Lean Clay (CL)	
Amount of Material Finer than the No. 200, %:	nm
LL: nm	PL: nm
PI: nm	G _s : 2.65 Assumed
Specimen Type: Undisturbed	Test Method: ASTM D2850

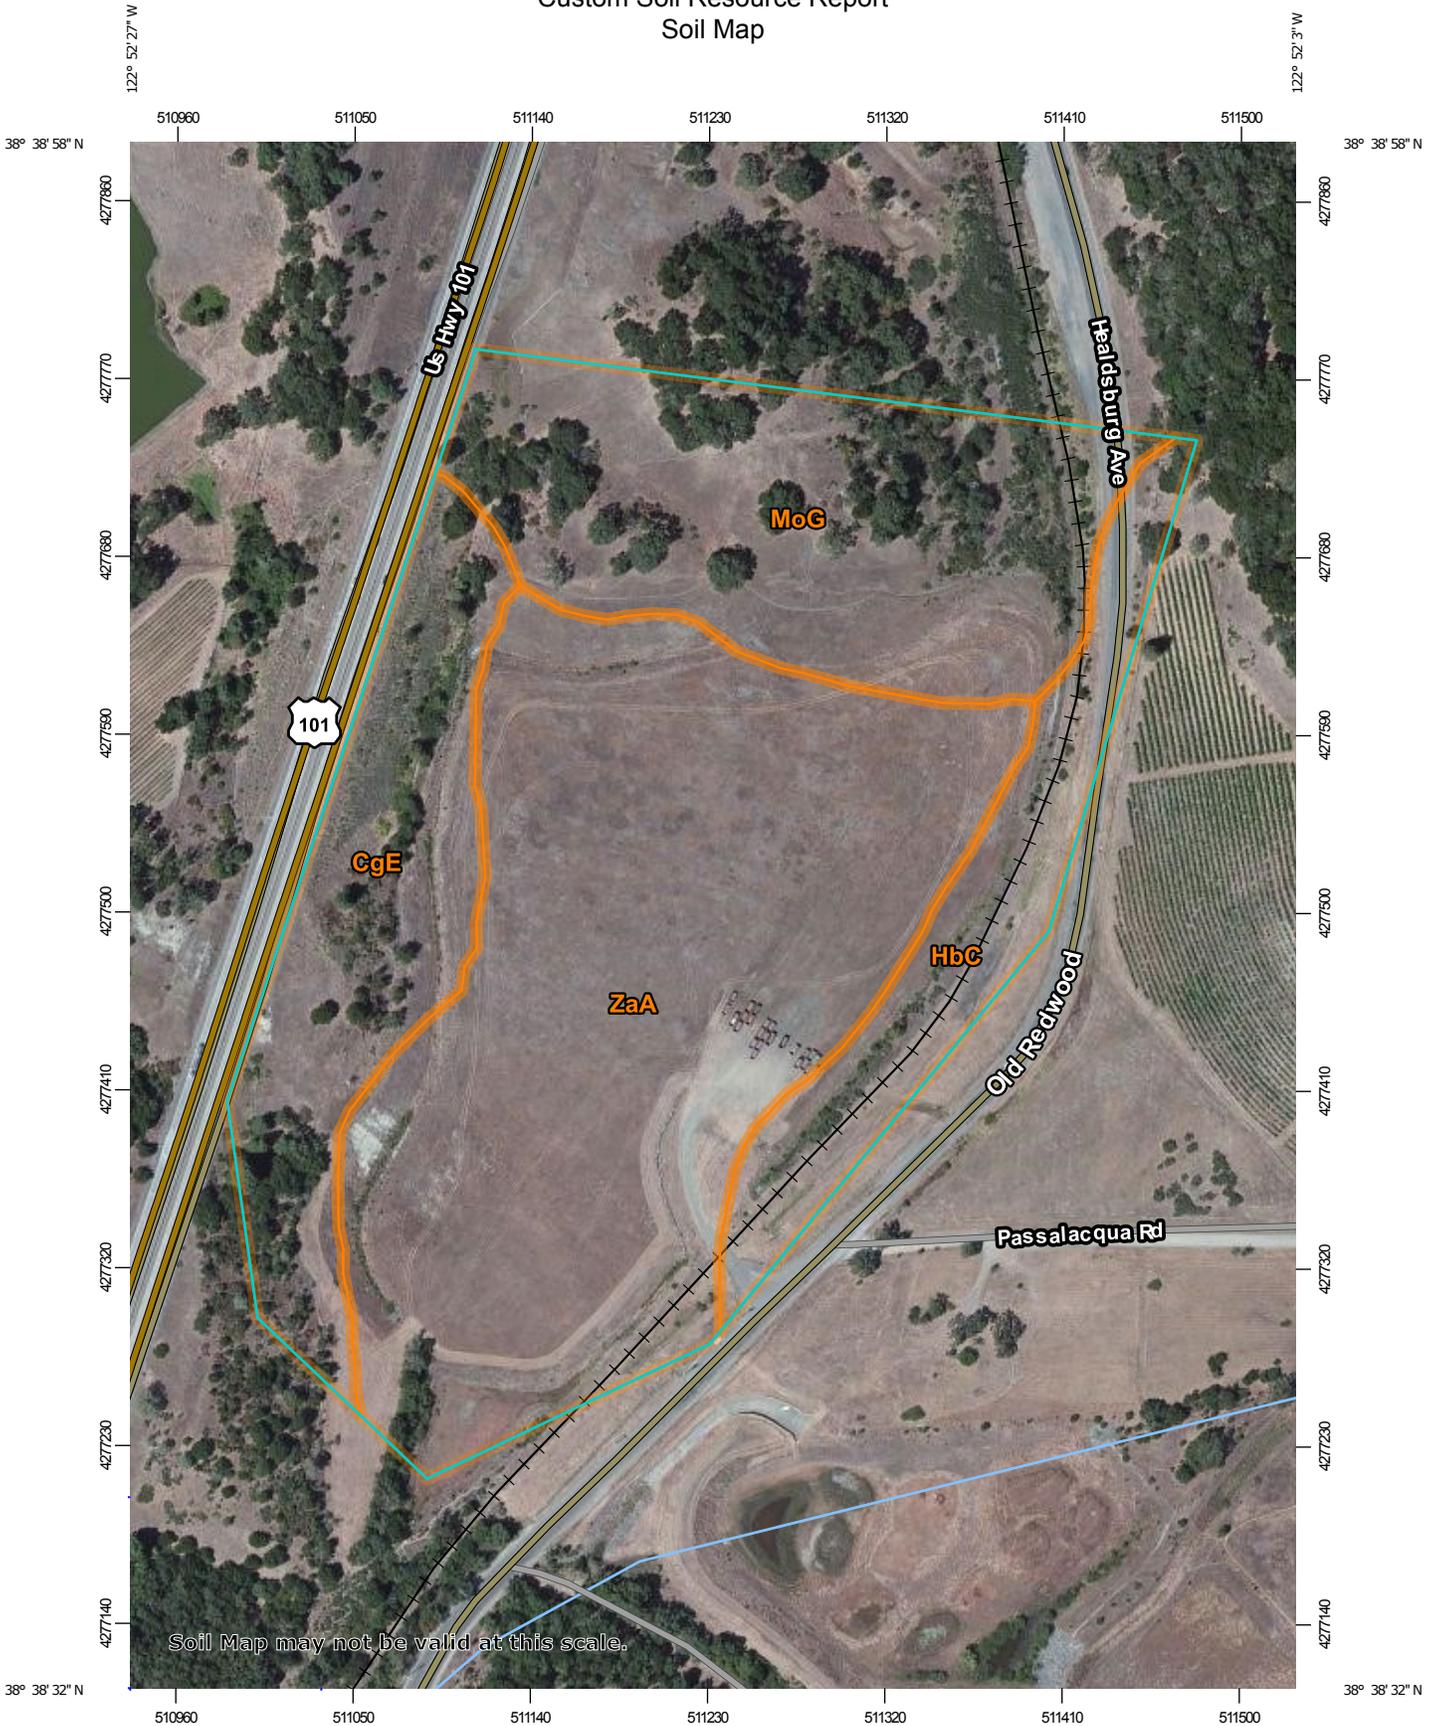
Custom Soil Resource Report Soil Map

The soil map section includes the soil map for the defined area of interest, a list of soil map units on the map and extent of each map unit, and cartographic symbols displayed on the map. Also presented are various metadata about data used to produce the map, and a description of each soil map unit.

Map Scale: 1:3,820 if printed on A portrait (8.5" x 11") sheet.
